Permafrost-related landslides in south and central Yukon

**Panya Lipovsky
Yukon Geological Survey**

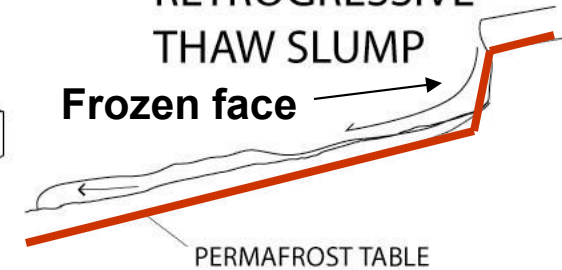
RETROGRESSIVE
THAW SLUMP
Frozen face

- Usually triggered by river erosion or disturbance of vegetation.
- Ice exposed in steep headscarp thaws and causes ongoing retreat.
- Material transported away in highly mobile flows that often travel several km.

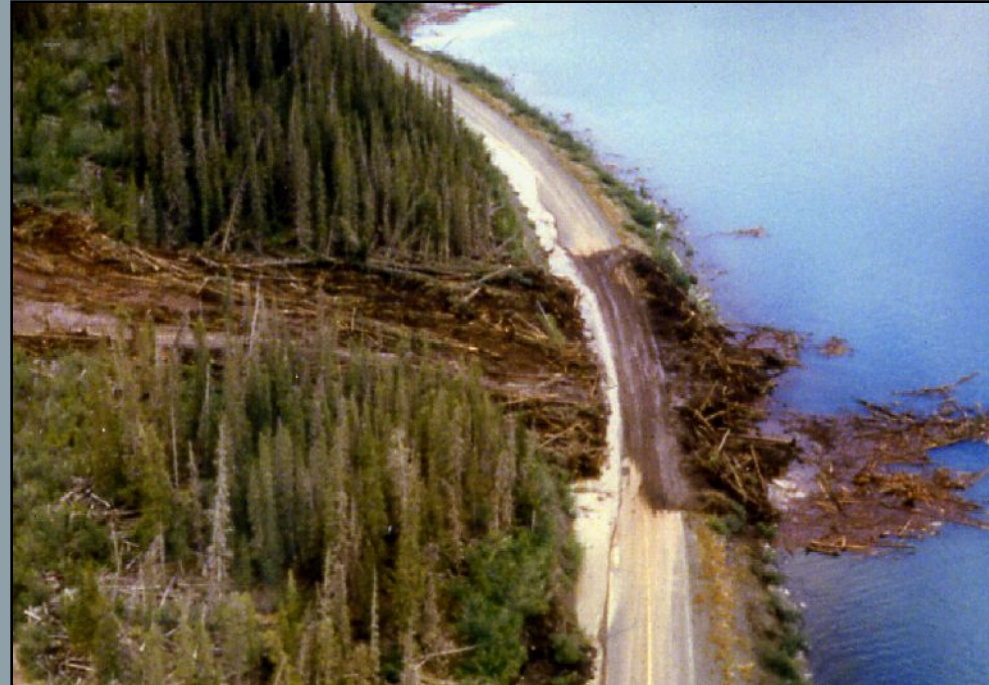
Photo by Ric Janowicz

July 8-15, 1988: 91.6 mm rain at Burwash Landing

Alaska Highway blocked by debris flows and floods in 8 locations along Kluane Lake. (Evans & Clague, 1989)

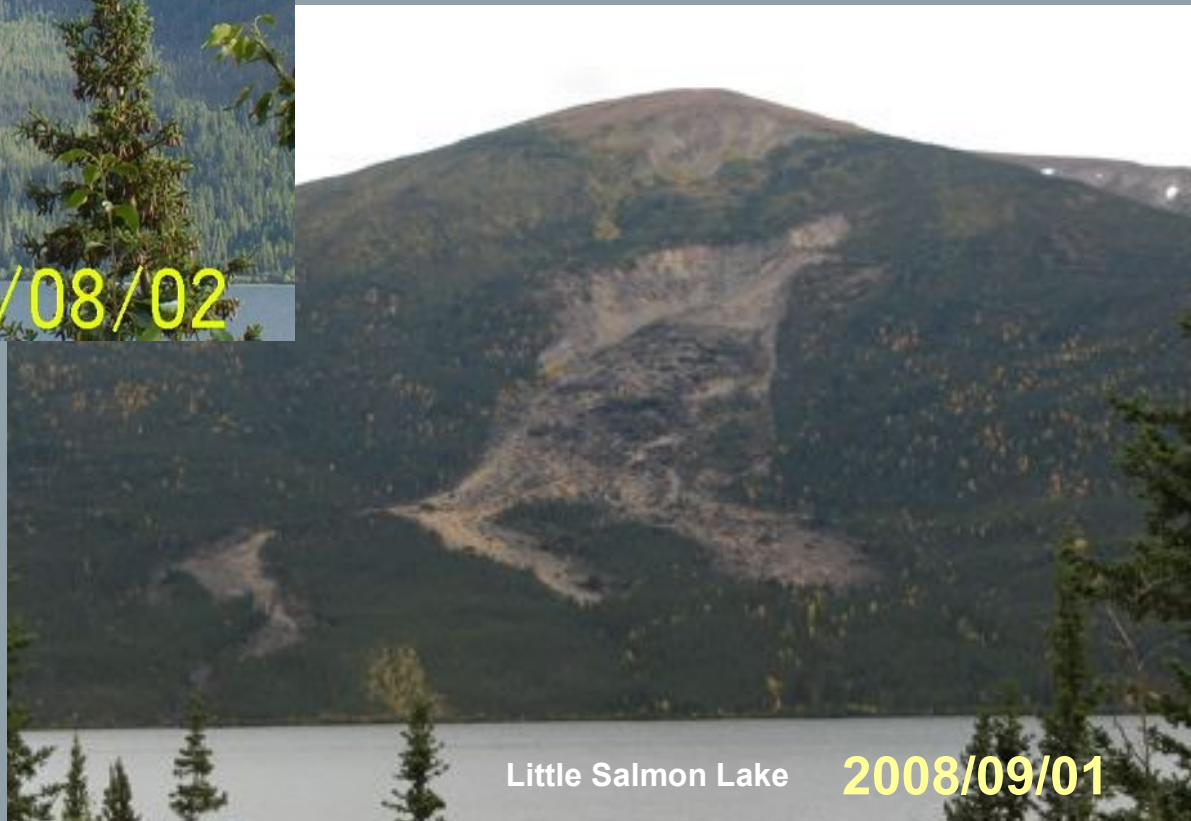
Little Salmon Lake 2008/09/01

Permafrost

- generally on north-facing slopes underlain by thick organic mats and silt-rich soils
- if present, restricts drainage
- if thaws, adds moisture and reduces strength

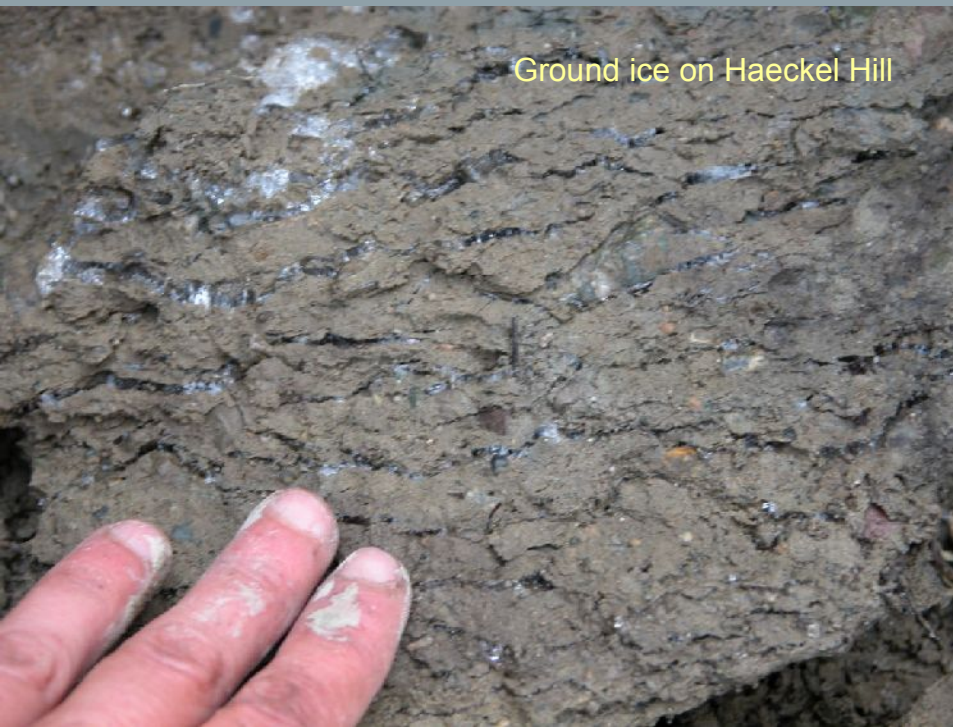
- In SW Yukon, permafrost is generally up to ~20 m thick, below an active layer of 1-2 m.
- Up to 25-40 m thick near Mayo (Burn, 1992) and 20-60 m thick near Dawson
- Up to ~300 m thick in northern Coastal Plain.
- In northern Alaska, permafrost is warming 0.25-1 °C/decade, mostly in response to increased snow depths (Osterkamp, 2007)
- In NWT (central/northern Mackenzie valley), permafrost is warming 0.3 to 0.6 °/decade in response to increasing air temperature (Smith, 2005)
- Permafrost in southern Yukon and NWT is considered “warm” (< -2 °C) and is not warming as fast.

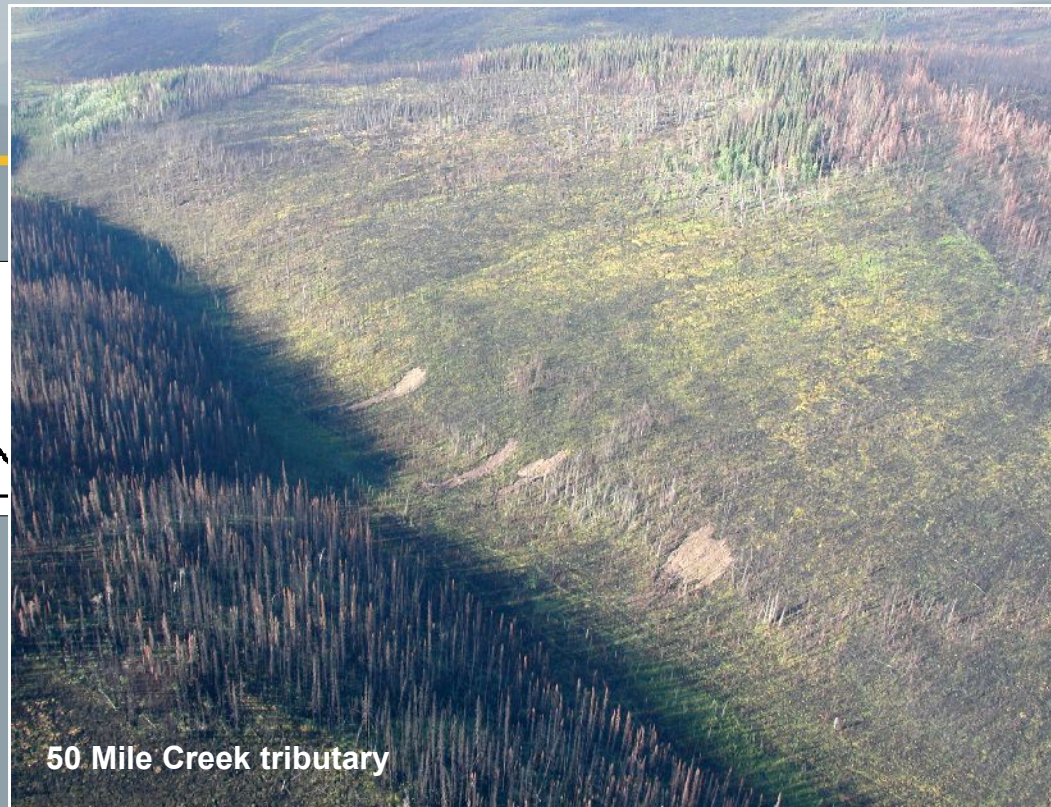
2004 Forest Fires near Dawson

- Almost 150 active layer detachments occurred in three study basins within one year of forest fires.
- Failures initiated in silty colluvium, on gentle to moderate slopes (generally 5-25 degrees), on a variety of aspects, and commonly near a convex break in slope.
- Most failures were shallow (50-80 cm) and on the order of 5-20 m wide x 10-100 m long.
- Combined effects are a potentially significant source of sediment to local streams and has implications for new placer regulatory regime.

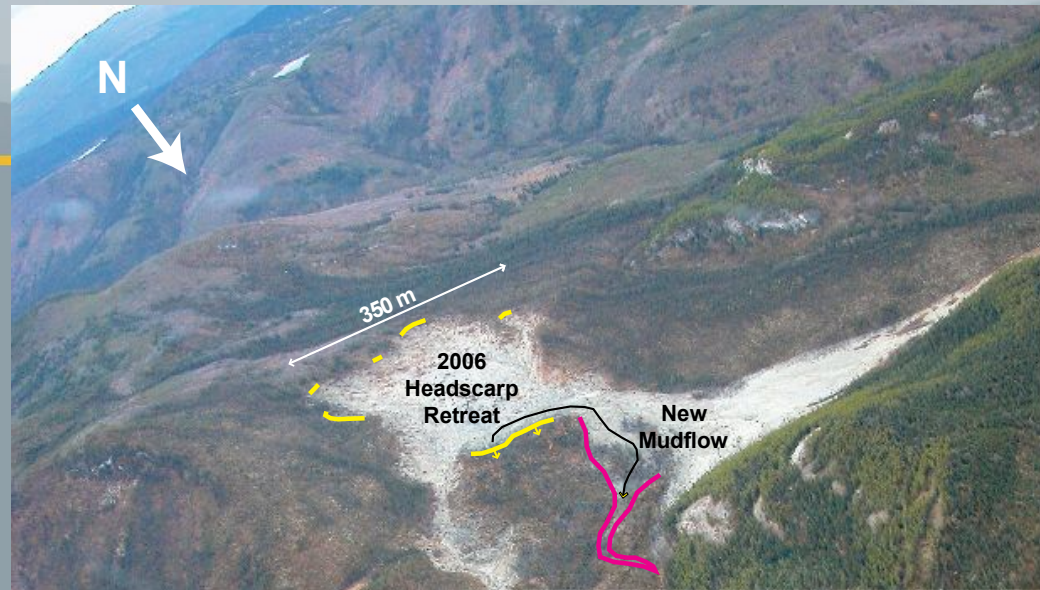
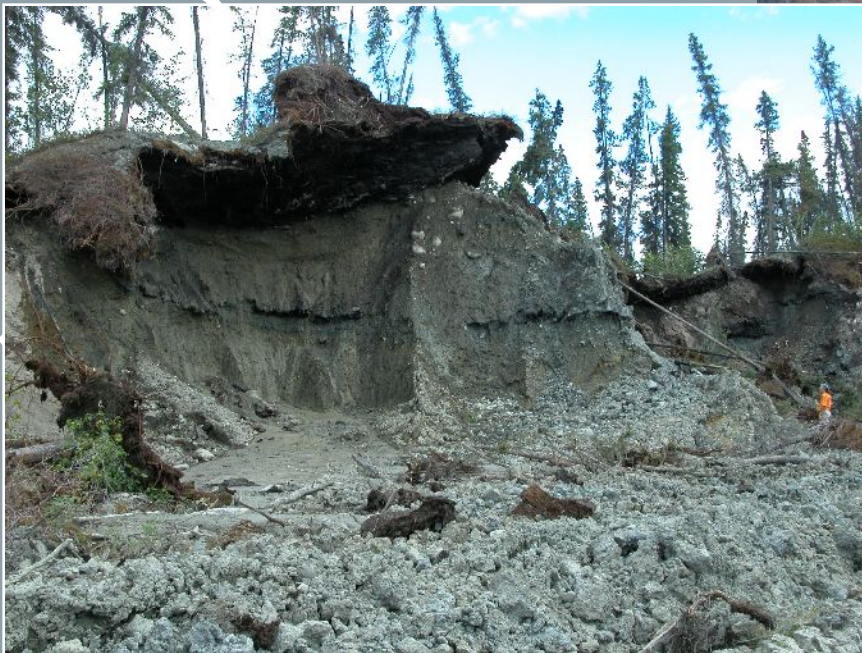
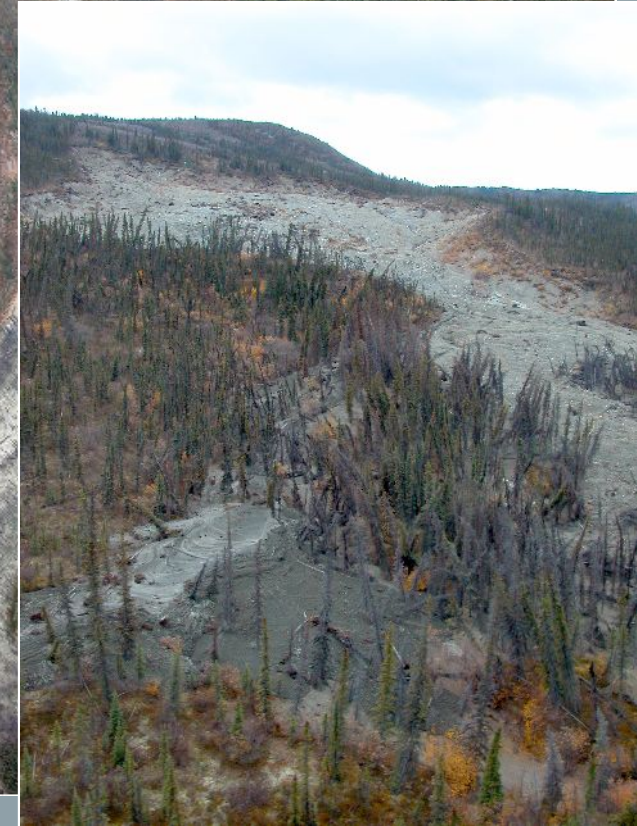
- River erosion exposed ice in glaciolacustrine terrace prior to 1971.
- Headscarp retreat rates:
 - 1971-1979: 25 m (3 m/yr for 8 years)
 - 1979-1987: 112 m (16 m/yr for 8 years)
 - 1987-present: a few meters
- Ongoing permafrost thaw related to thermal and hydrological disturbance from highway and nearby cleared fields.
- Buried utility lines rerouted above ground and ongoing highway maintenance required.

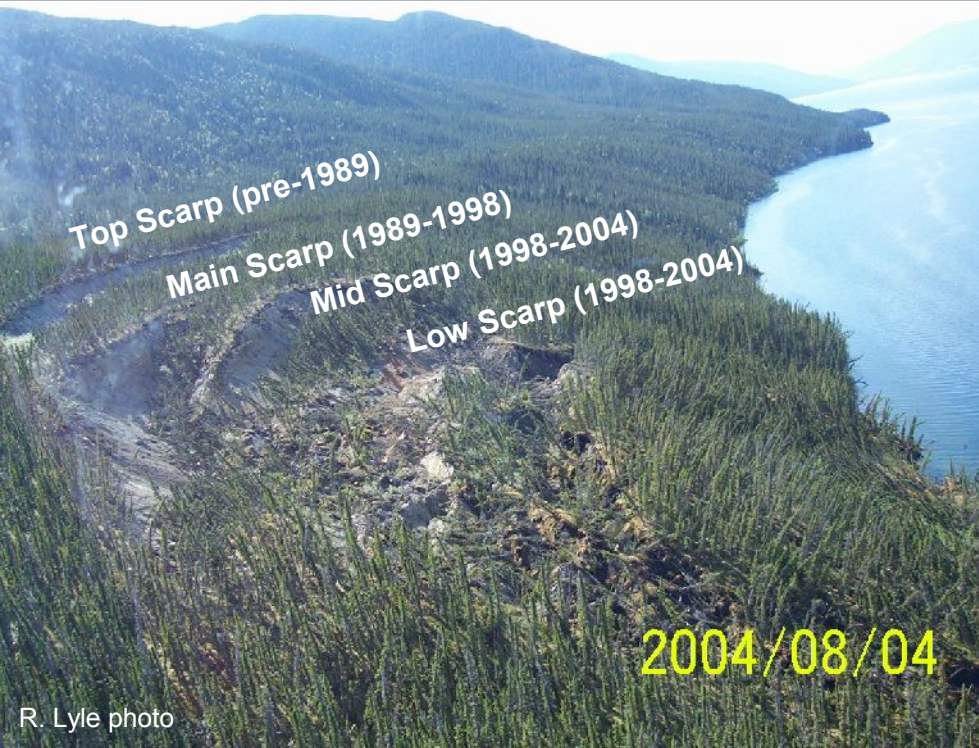
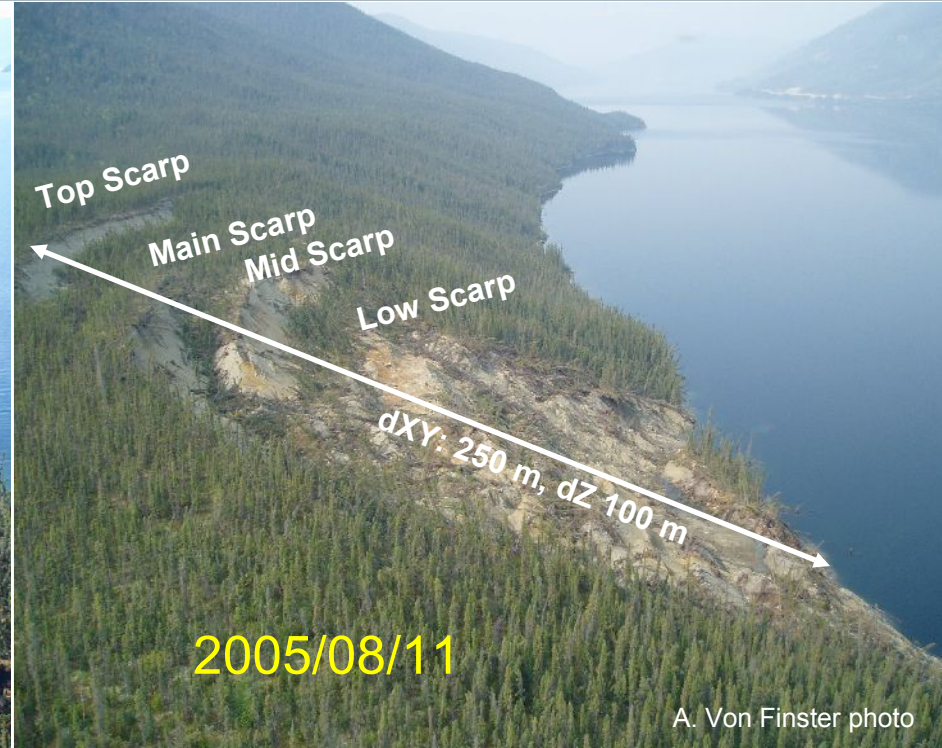
Aspect = North

Adjacent Undisturbed Slope = 16°

Elevation Drop = 100 m

Length = 250 m

Width = 350 m

Area Impacted = 5.8 ha

Dates Active = pre-1989 to present

- **Scarps developed between 1989 and 2004.**
- **Large block below low scarp disappeared into lake between 2004-2005.**
- **Causal factors:**
 - creep of “warm” ice-rich permafrost on slope
 - high ice contents from groundwater flow through confined glaciofluvial sediments
 - thermal erosion by lake

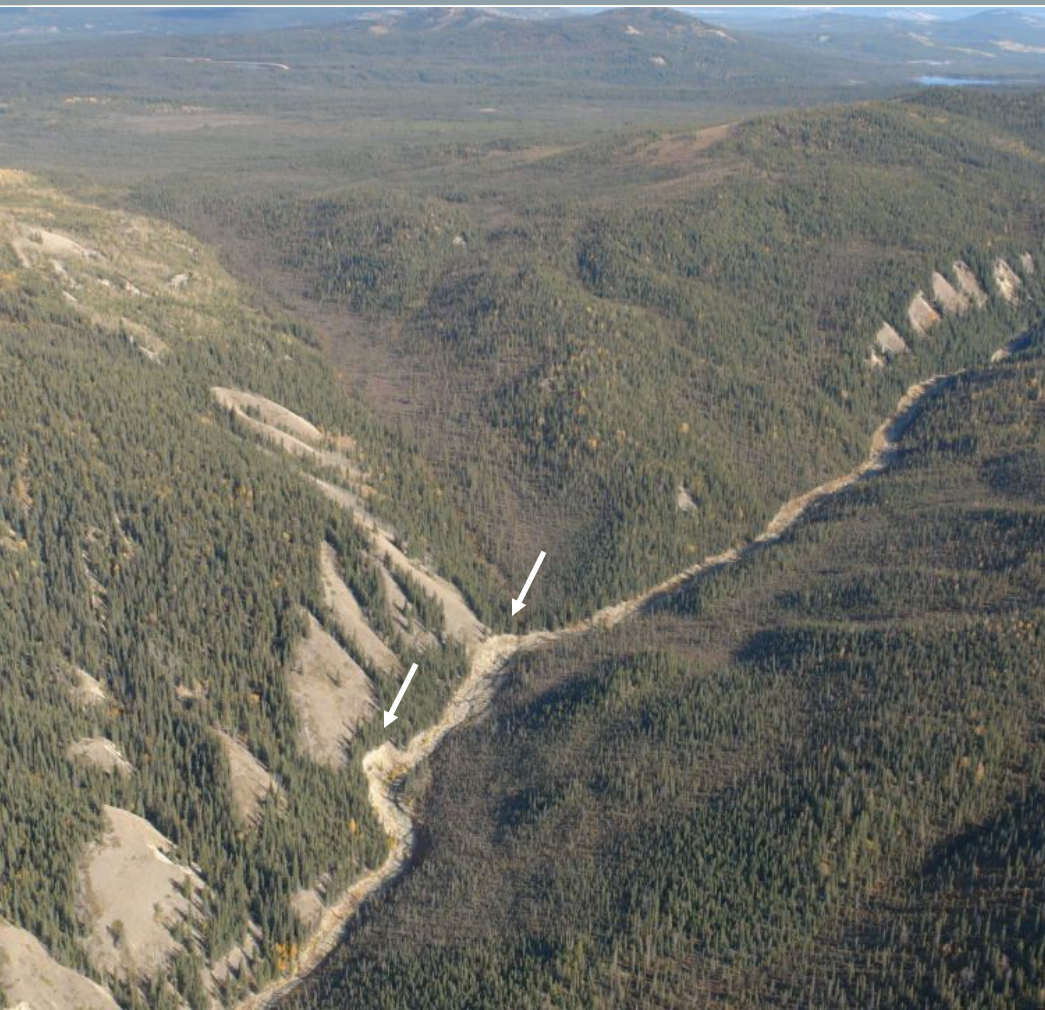
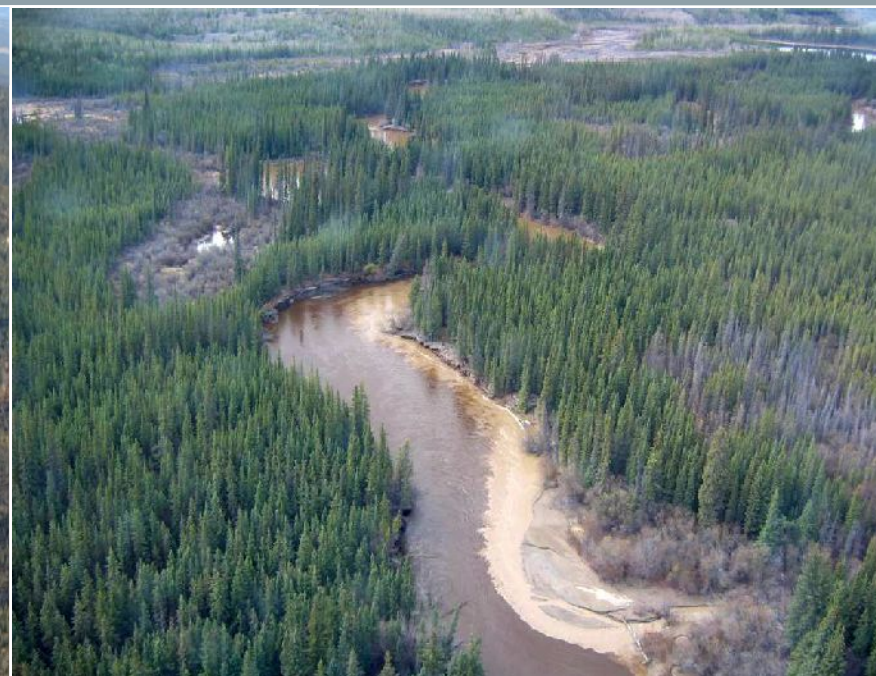
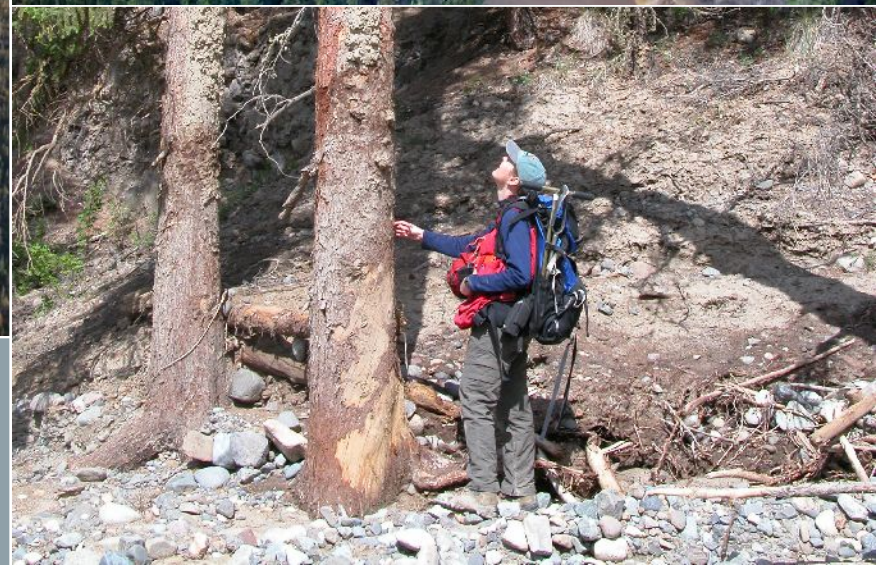
- Frozen till confined permeable glaciofluvial deposits during high snow melt, triggering massive debris flow.
- Debris flow travelled nearly 5 km at speeds up to 40 km/hr).

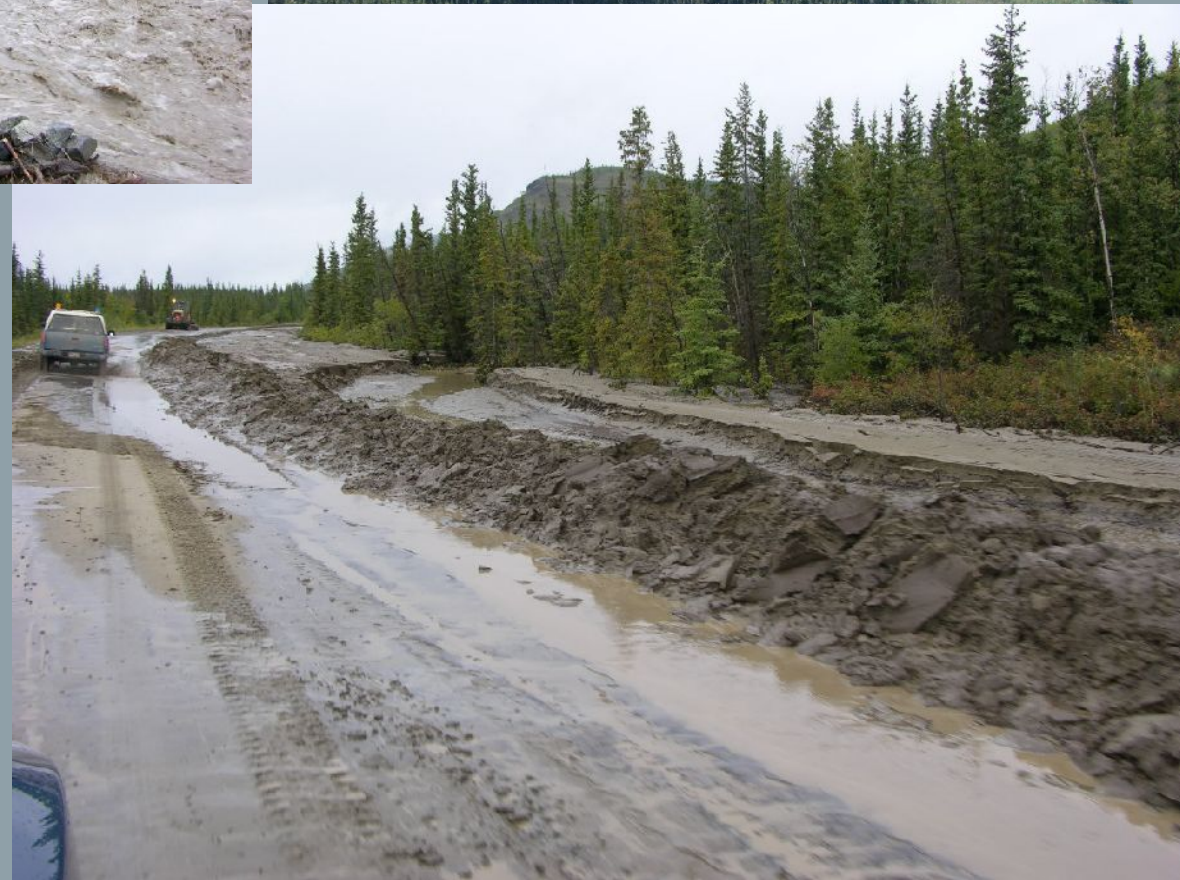
August 2008 record rainfall:

- Carmacks: 62 mm rain in 5 days
 - Burwash: 120 mm in 4 days
- (Environment Canada)

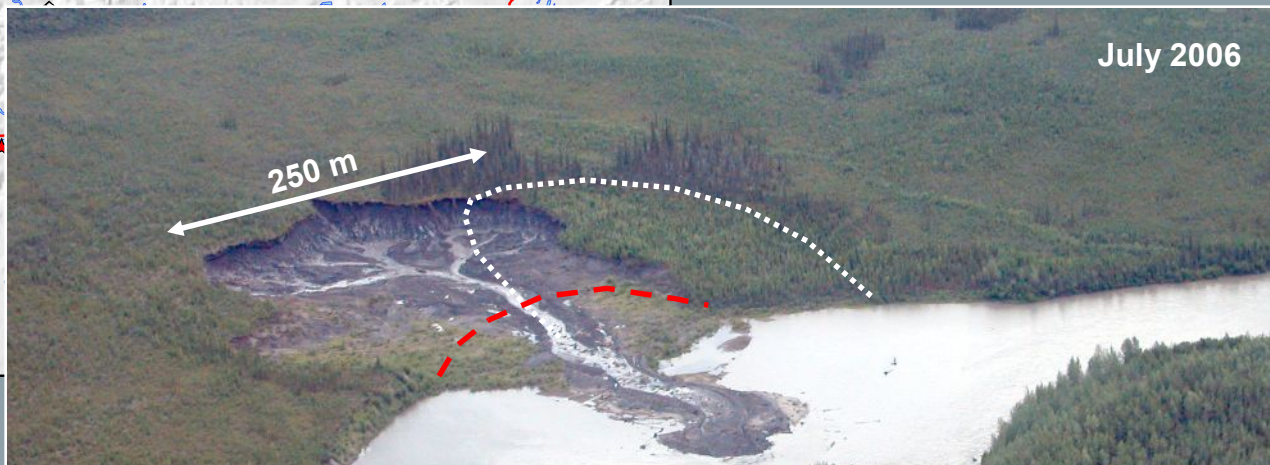
- Has retreated about 10 m/yr for last 17 years.
- Older overgrown slide just adjacent.
- Small slide, but capable of damming $\frac{3}{4}$ of MacMillan R. since at least 2003.

Aspect = North

Adjacent Undisturbed Slope = $<5^\circ$

Elevation Drop = <10 m

Runout Length = 275 m

Width = 250 m

Area Impacted = 3.7 ha

Date Initiated = pre-1989
